# UTB Systems Center *Newsletter*

FIRST AND SECOND QUARTER

FISCAL YEAR 2001

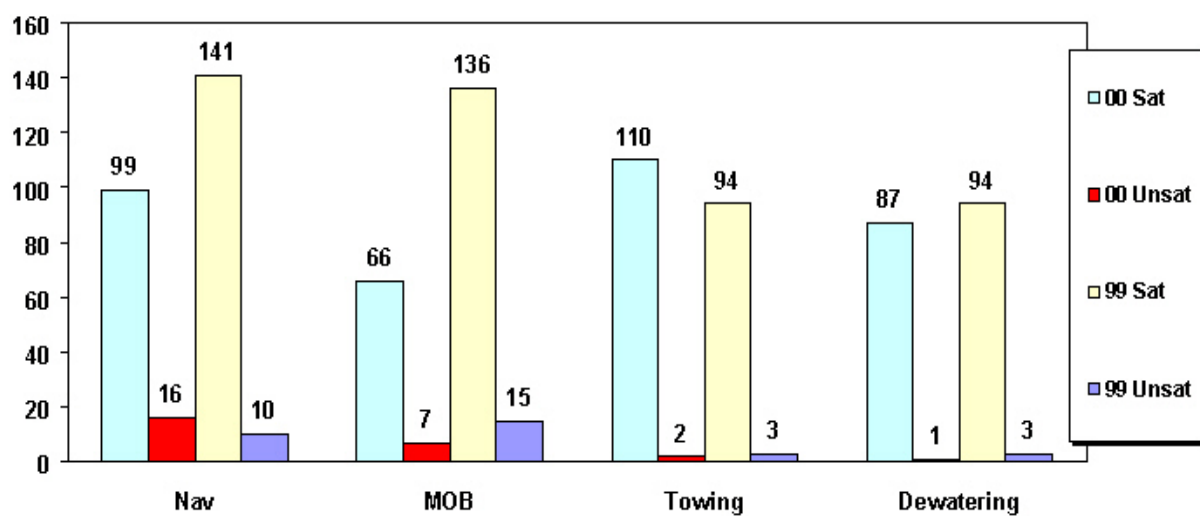
**2000 Core Drills**

Core Drills	Number of Drills	Satisfactory	Unsatisfactory
Day/Night Navigation & Piloting	115	99	16
Man Overboard	73	66	7
Towing	112	110	2
Dewatering	88	87	1

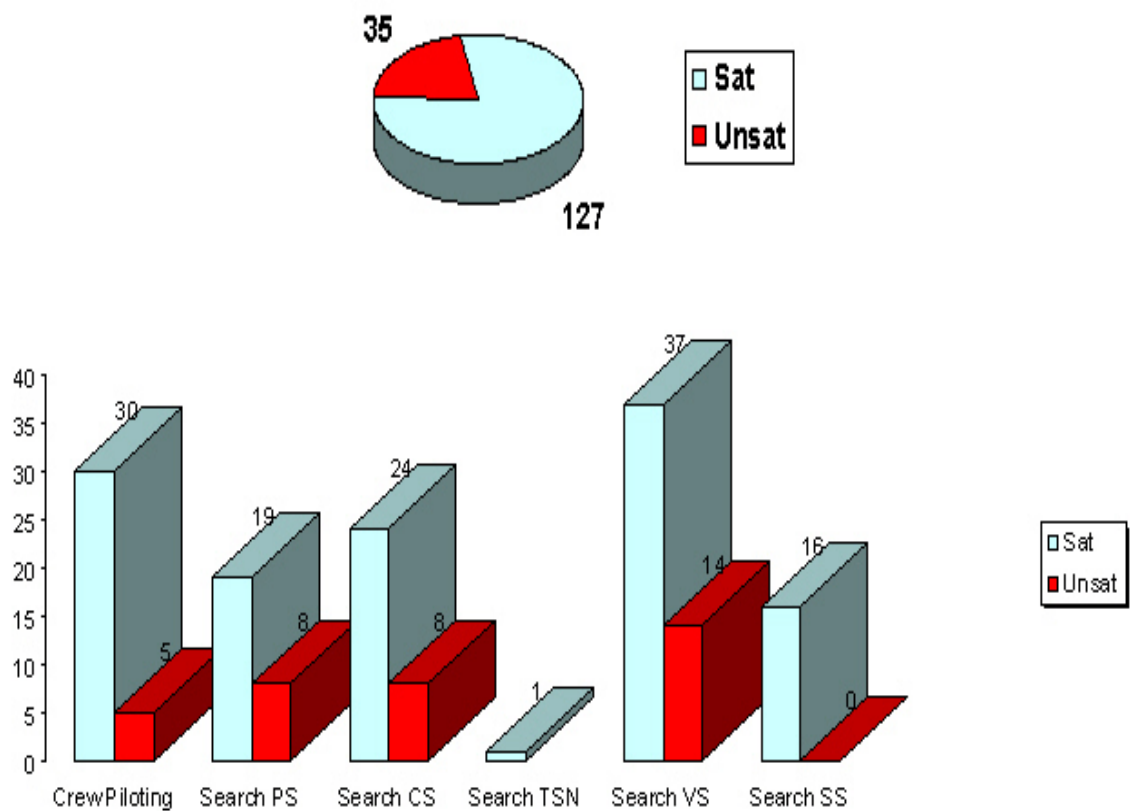
2000 Optional Drills

Optional Drills	Number of Drills	Satisfactory	Unsatisfactory
Crewmember Piloting	35	30	05
Search Pattern (PS)	27	19	08
Search Pattern (CS)	32	24	08
Search Pattern (TSN)	01	01	00
Search Pattern (VS)	51	37	14
Search Pattern (SS)	16	16	00

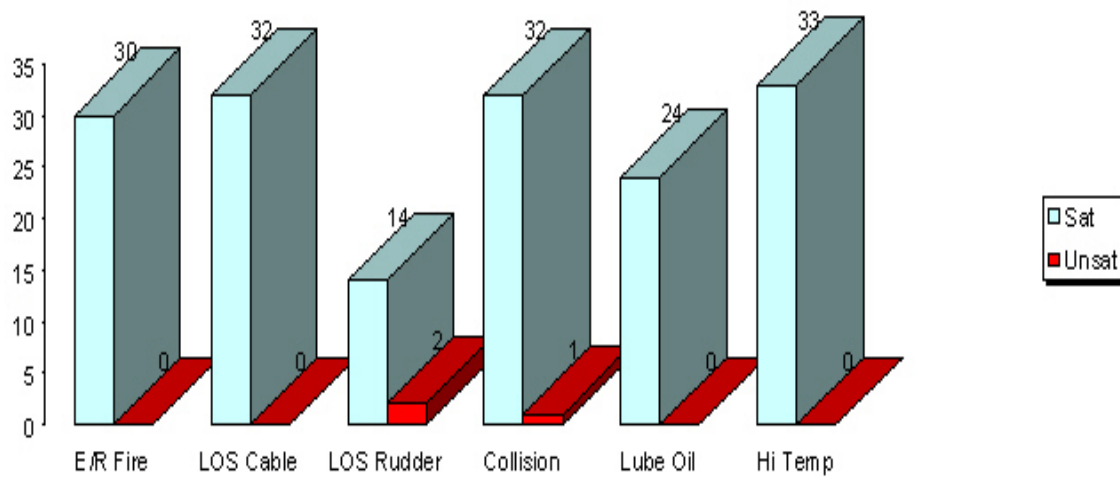
Optional Drills (continued)	Number of Drills	Satisfactory	Unsatisfactory
Engine Room Fire	30	30	00
Loss of Steering (cable/hydraulics)	32	32	00
Loss of Steering (jammed rudder)	16	14	02
Collision with Submerged Object	33	32	01
Loss of Main Engine L/O Pressure	24	24	00
High Water Temperature	33	33	00
